TECHNICAL REPORT NO. 2-580

+6  
2 SAVANNAH HARBOR INVESTIGATION AND MODEL STUDY

# RESULTS OF TESTS OF BANK EROSION IN NORTH CHANNEL

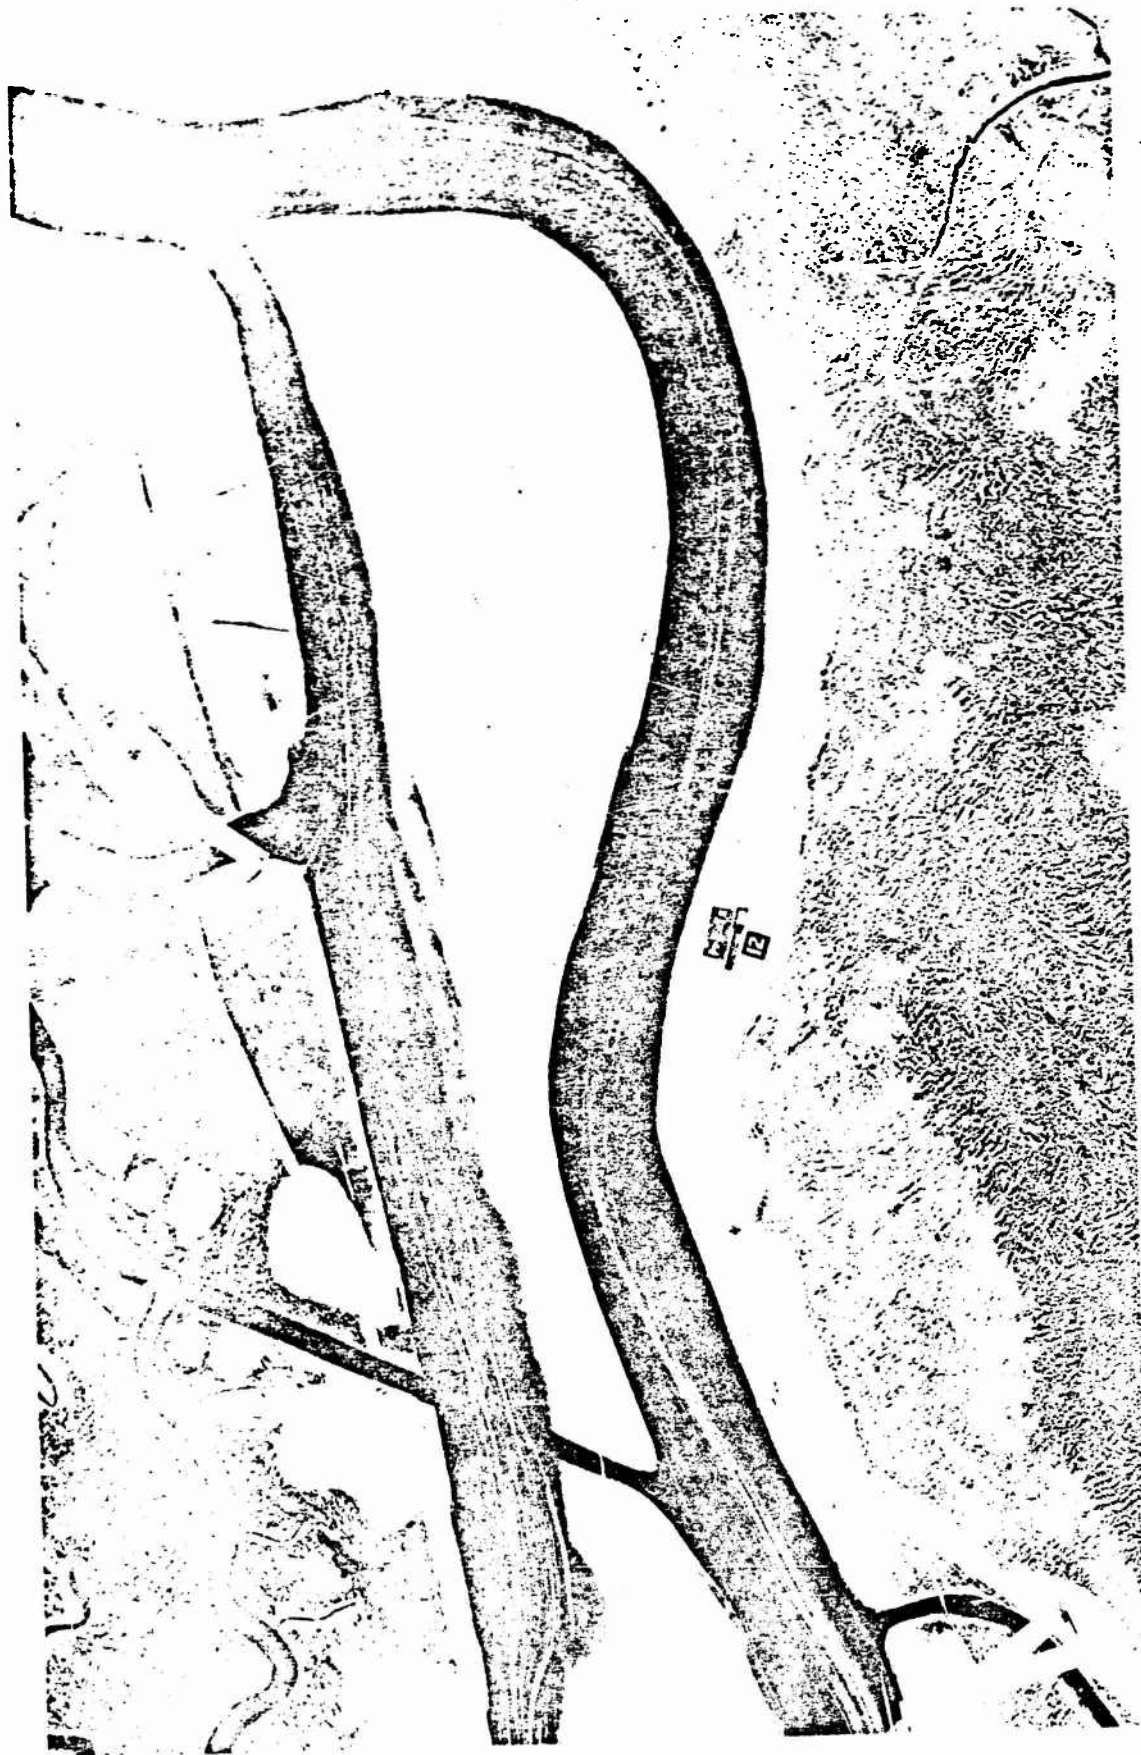
Photograph 26. Surface current directions and velocities for recommended channel enlargement.  
Hour 12, ebb tide

8. Comparison of photographs 1-13, which show surface current directions and velocities for the 1964 channel conditions at hourly intervals throughout a complete tidal cycle, with photographs 14-26, which show similar information for the recommended channel enlargement, indicates that the enlarged channel would cause no significant changes in surface flow patterns and velocities. In these photographs, the velocity of the surface current in feet per second prototype in any area of the channel can be determined by measuring the length of a confetti streak in inches and multiplying by 2.64. This factor takes into consideration the scale of the photographs and the model-to-prototype scale relations for distance, time, and velocity.
